BT01-050

ITB01-076

**2001-2002 G20; RIGHT HAND WINDSHIELD DEFROSTER VENT NOT FLUSH
AND/OR MAKING RATTLE NOISE**

APPLIED VEHICLE(S): 2001-2002 G20 (P11)

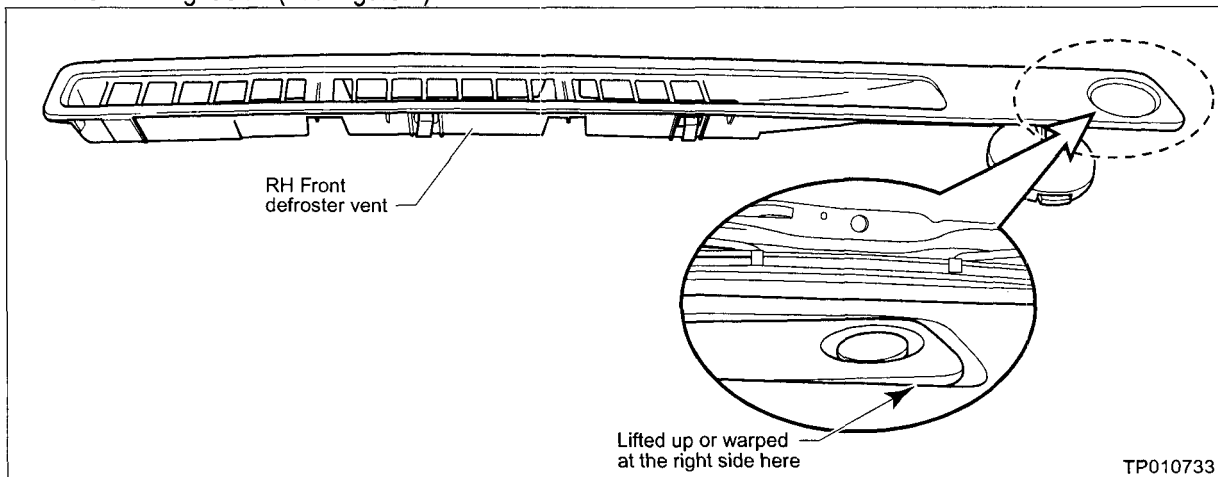
Figure 1

- Right hand defroster vent is not flush with the dash panel (right side vent).
- Rattle noise from the right side of the right hand defroster vent (see Figure 1)

1. Check if the defroster vent is not flush with the dash panel (right side of vent) and/or there is a rattle noise from the right side (see Figure 1).
